NATIONAL BUILDING INSPECTORS

CONFIDENTIAL INSPECTION REPORT

123 Anywhere St, Olympia, WA 98501

10/27/2008

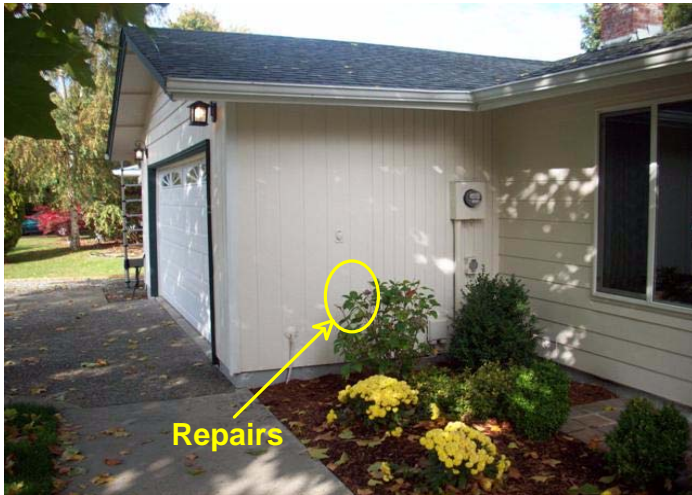
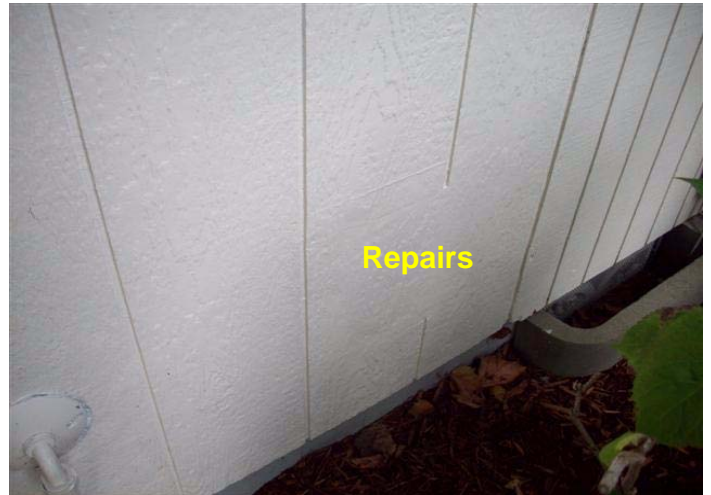
Evidence indicates that past repairs have been performed to the siding at the front adjacent to the electrical meter. We recommend verifying the problem, its cause, and the extent of repairs performed with the owner. No statement is given with regard to concealed areas (if any). If the property owner cannot supply substantiation, we recommend contacting a qualified contractor prior to the close of escrow for further investigation.

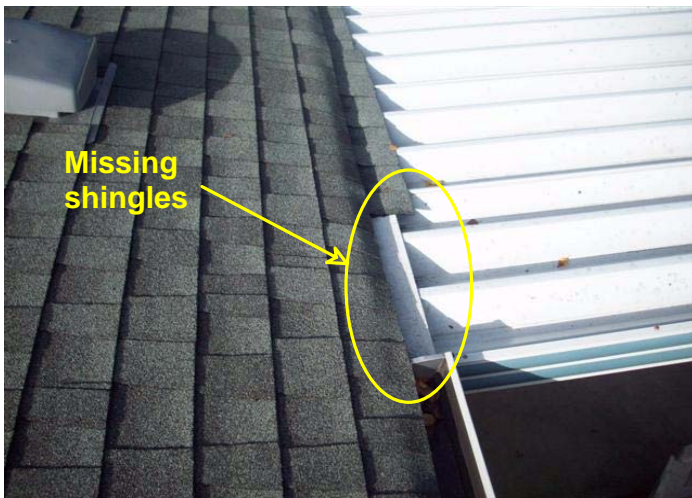
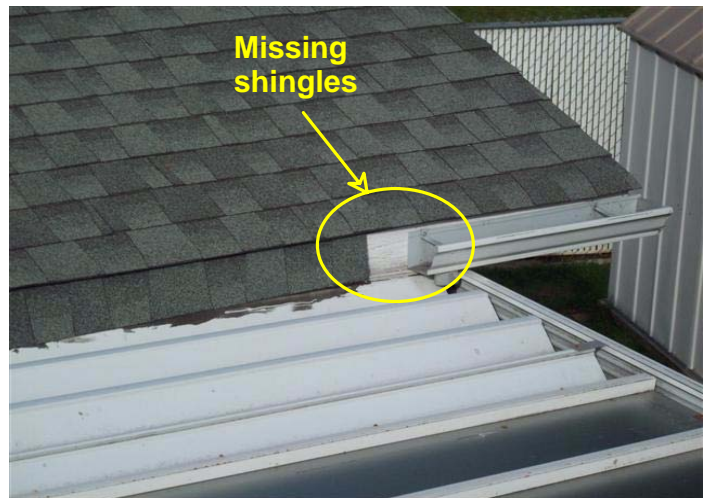
Shingles are serving as flashing at the patio roof connection. There are several missing shingles in this area. We recommend installing shingles in these locations to prevent leakage.

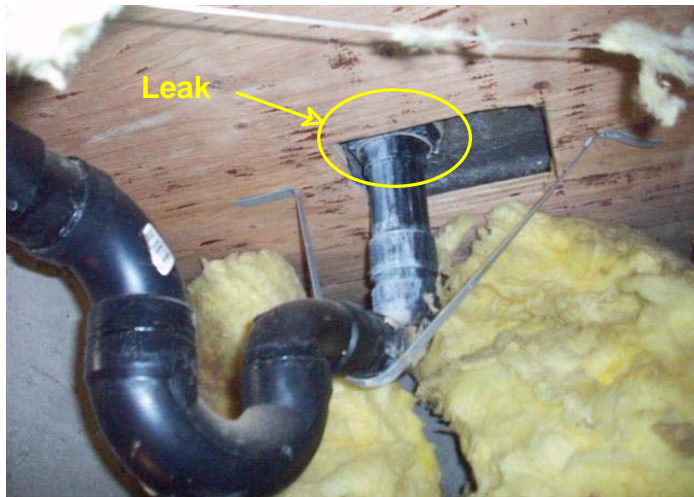
A drain line line under the laundry shower is leaking. We suggest contacting a qualified plumbing contractor recommendations and any corrective work that may be required.

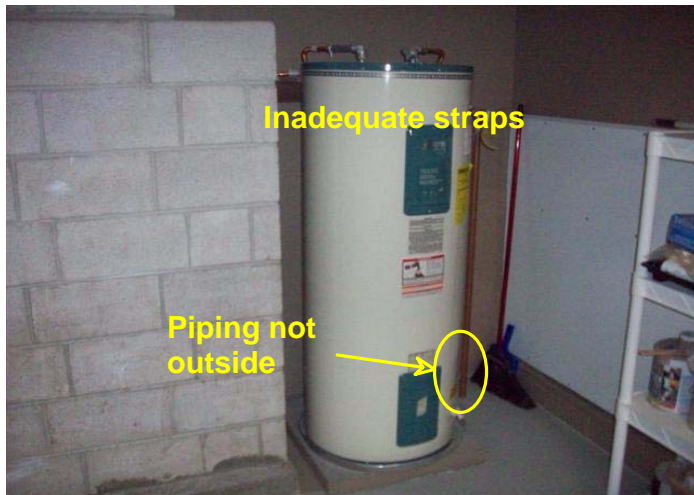
The seismic bracing on the water heater is not adequate to protect it from tipping over if an earthquake occurs. Adequate bracing necessitates having ample metal straps bound around the top and bottom thirds of the heater and then bolting them into the wall framing on opposite sides of the water heater. We recommend having proper straps installed in the near future for additional safety.

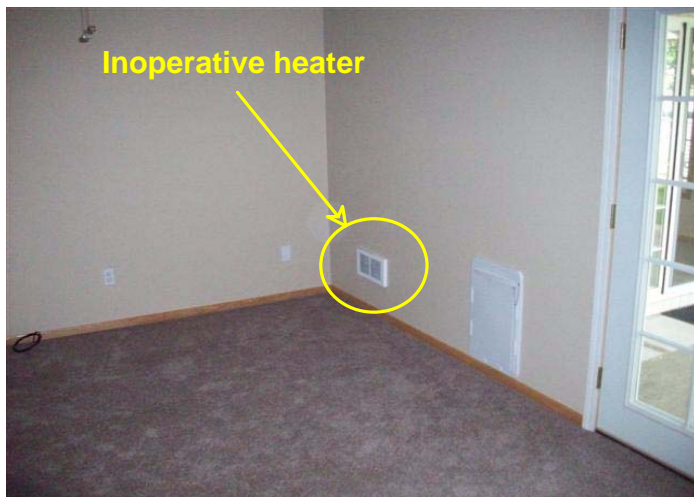
The electric wall heater in the family room did not appear to be operating at full output. Recommend it be repaired or replaced.

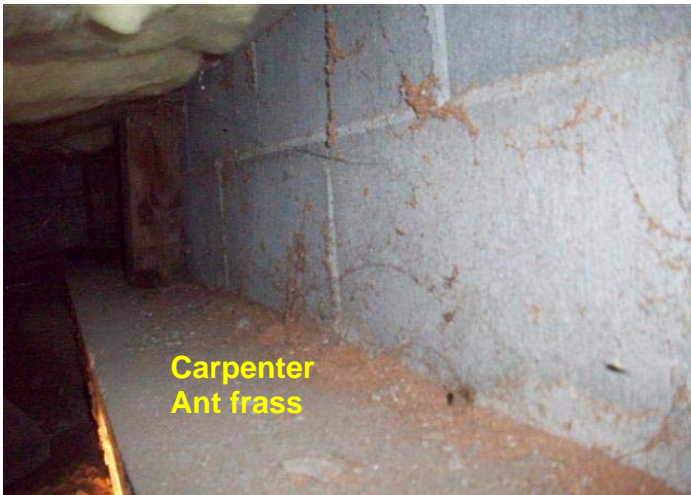
We noted signs of a carpenter ant infestation along the foundation adjacent to the right of the garage. We recommend having the home treated with a registered pesticide.
